PROGRESS REPORT FOR THE CONSTRUCTION OF A MINI PIPED WATER SUPPLY SCHEME AT NABINENE PRIMARY SCHOOL

**Prepared for:
NABINENE PRIMARY SCHOOL**

**Prepared by:
LIVING WATER
TECHNOLOGIES LIMITED**

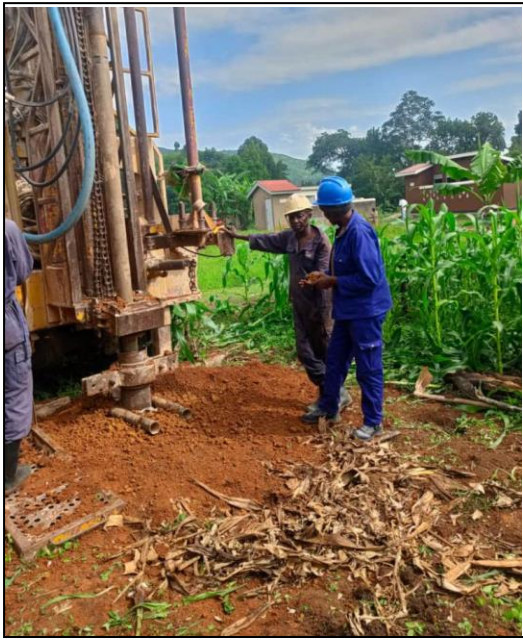
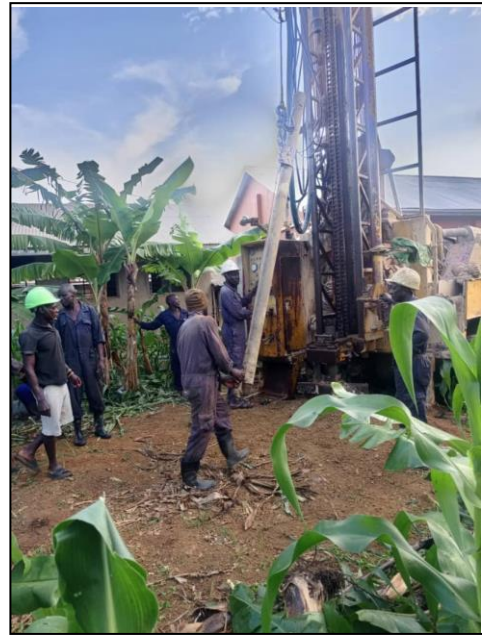
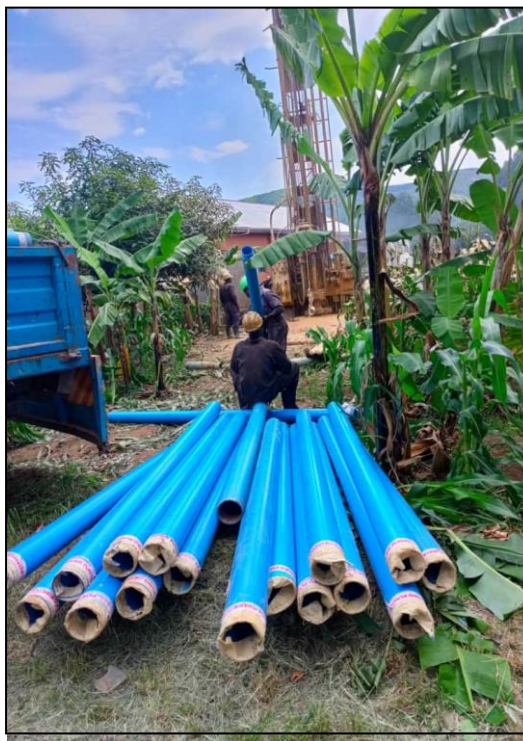
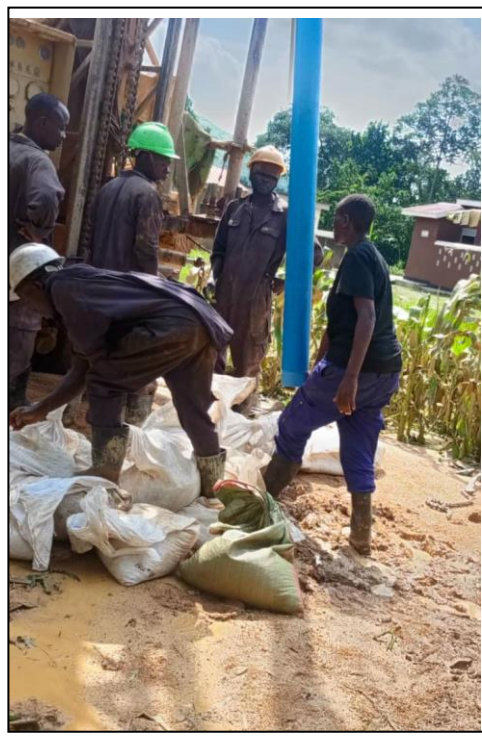
Figure 1: Borehole drilling

Drilling operations were conducted between June 3rd and 5th, 2025. The borehole was drilled to a total depth of 42.65 meters with an 8" down-the-hole (DTH) hammer. The main lithologies identified during drilling included clayey soils and sandy weathered formations.

Water-bearing zones were encountered at depths of 20 meters and 29 meters. A full casing design was adopted and 5" permanent PVC casings were installed up to 36.65 meters. The casings did not reach the bottom of the well because of boulders that were encountered between 37 and 43 meters. The annular space between the borehole wall and casing was packed with 60 bags of gravel, and a sanitary seal was constructed using cement. The borehole produced an estimated airlift yield of 4,000 litres per hour.

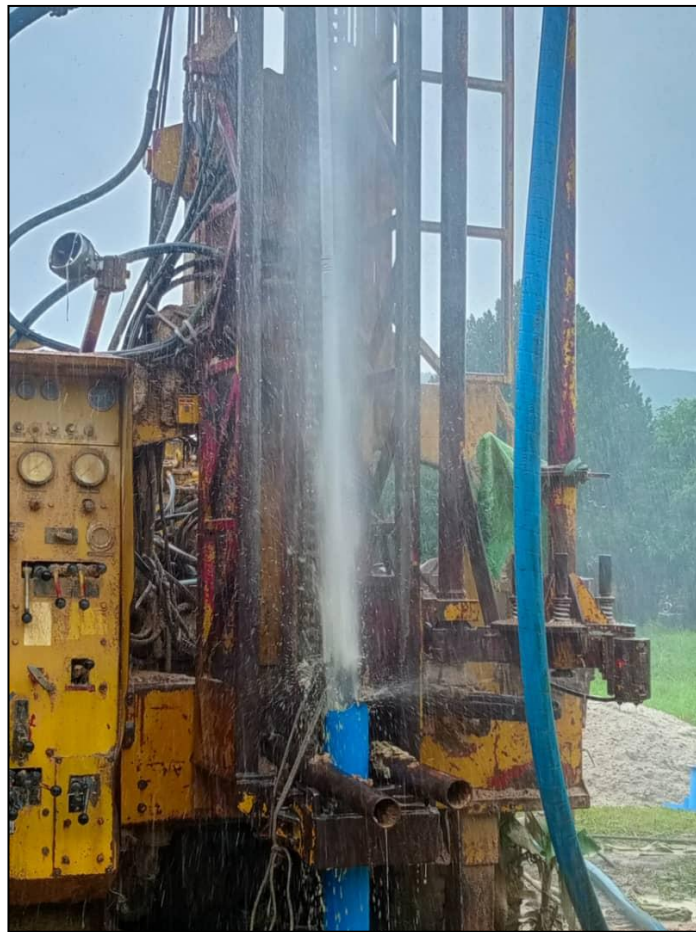
Figure 2: Borehole development

This involved cleaning the borehole to remove native silts, clays, cuttings and drilling fluid residues deposited on the borehole walls during the drilling process. This was done at the end of the drilling process. Proper well development is important and if done well, can increase the yield by 20-30%. If the development process is not well done, the results could be opposite and decrease the yield by 20-30%. Well development also ensures that all fine particles are cleared through the gravel pack. The borehole was cleaned by airlift pumping and surging method where compressed air was injected via the airline to drive water upwards within the drill pipe with no water being forced back into the formation. Development was done for one hour and the supervisor was contented that the water was clear and free of any particles. After well development, a sanitary seal was cast using cement grouting and this was to prevent the borehole water contamination. A protective chamber was also constructed at the borehole source.

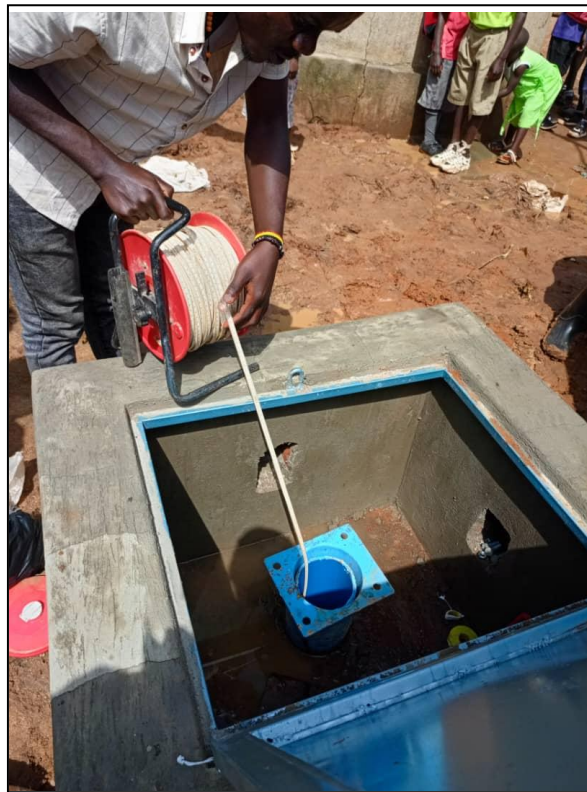
Figure 3: Test pumping of the borehole

A 6-hour constant test was carried out, at the start of test pumping, the following was done;

- Taking the measurement point of the casing above the ground level.
- Measurement of static water level of the borehole.
- Installation of the submersible pump at an appropriate depth into the borehole.
- Carrying out constant discharge for 6 hours.
- Carrying out recovery test.

Constant discharge test; this determines the aquifer's ability to yield sufficient water under constant pumping conditions. The results were used to determine the optimum installation depth and pumping hours.

Recovery test; which is used to determine how fast the aquifer responds after pumping stops, was monitored. This was also considered when determining the installation depth and optimum pumping hours.

The safe yield of the well was ascertained to be **3m³/Hr** and the optimum pump installation depth to be **31m**.

Borehole Depth	42.65
Static Water Level	6.28m
Pump Installation Depth	31m
Available Drawdown	24.22m
Driller's Yield Estimate	4m ³ /Hr
Constant Discharge Yield	3.2m ³ /Hr
Draw Down after constant Discharge	11.89m
Dynamic Water Level after Constant Discharge	18.17m
Recovery After Constant Discharge	95.1% after 30 minutes

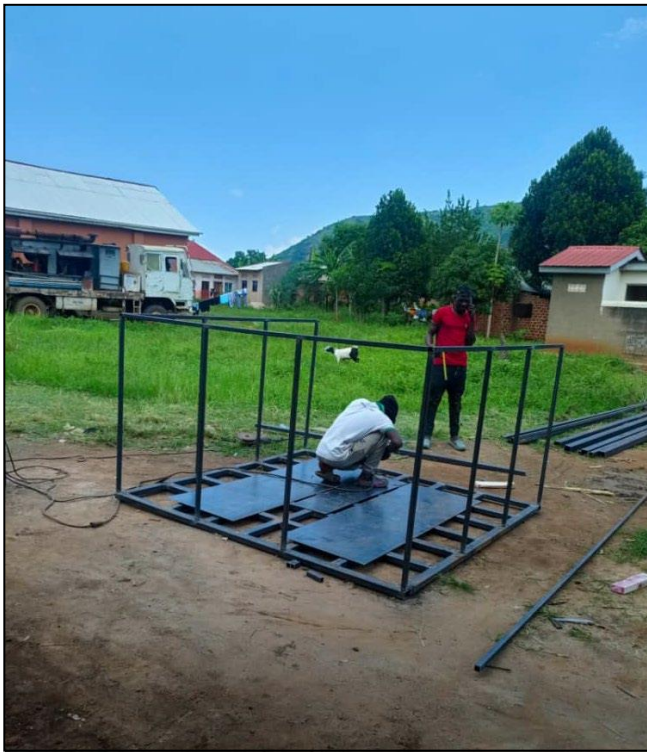
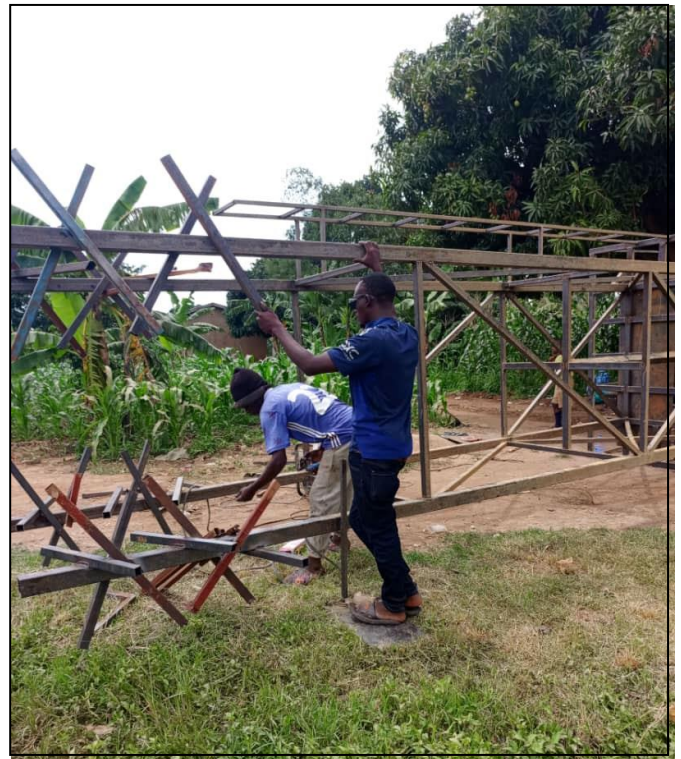
Figure 4: Construction of the steel tank stand

The tank stand is a robust, elevated steel structure designed to support a **5,000-liter plastic Gentex water storage tank** for gravity-fed distribution. Standing at a height of **6 meters**, the structure is fabricated from rectangular hollow steel sections, assembled and welded on-site. The design features four vertical support columns reinforced with diagonal cross-bracing to ensure structural stability against both vertical loads and lateral forces such as wind. A steel platform forms the tank's base, bordered by a safety railing to facilitate secure access during maintenance. The entire stand is anchored onto a reinforced concrete plinth foundation, providing a stable base and preventing settlement or tilting over time. During construction, the steel members were cut, assembled, and joined by arc welding, forming a sturdy rectangular frame that was then erected and secured. After anti-corrosive paint was applied, the **5,000-liter Gentex tank** was lifted and carefully installed on the platform. Additionally, **plumbing works** were completed to connect the tank to inlet and outlet pipes, enabling it to function as a reliable, gravity-fed water supply system for the school. The elevated height ensures adequate water pressure at distribution points while protecting the tank from contamination and unauthorized access.

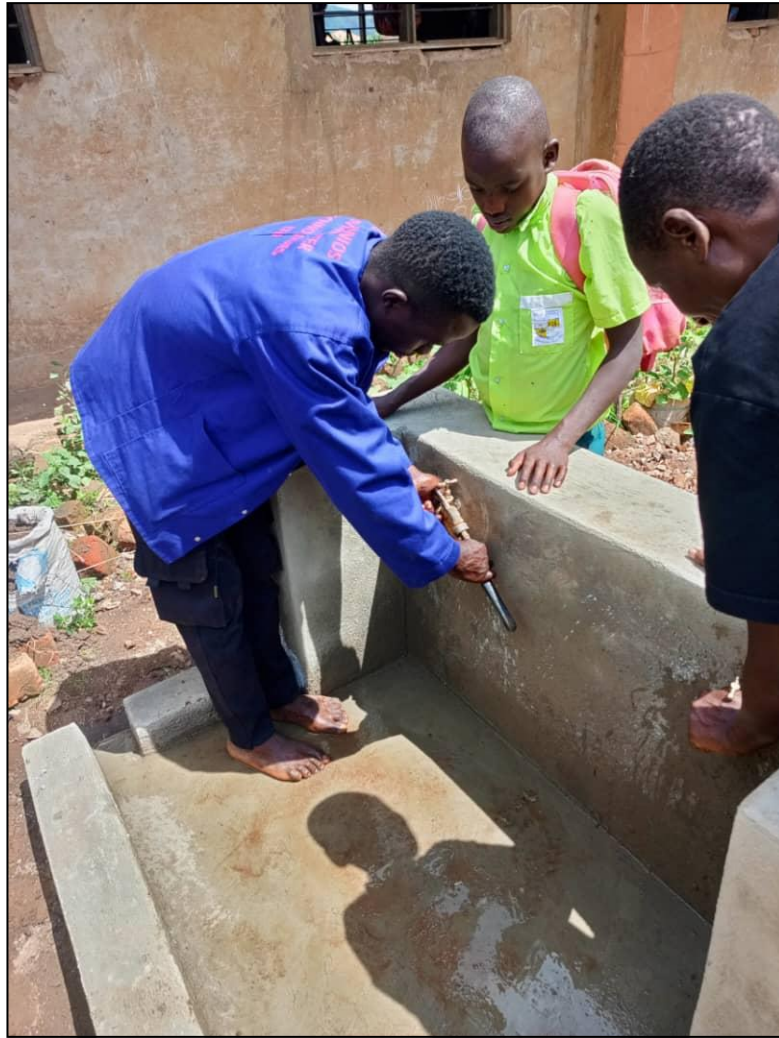
Figure 6: Installation of concrete tap stands

Two concrete tap stands were constructed as part of the mini piped water supply system at the primary school, each equipped with two taps. These tap stands are strategically positioned to ensure easy access for students and staff. Built from reinforced concrete, the structures are designed for durability and hygiene, featuring a sloped base to allow efficient drainage and reduce standing water. The tap stands are fed by the elevated 5,000-liter Gentex tank mounted on a 6-meter-high steel tower, ensuring a reliable gravity-fed flow of water. This setup provides a clean and accessible source of water for drinking and sanitation, significantly improving the school's water infrastructure and promoting better hygiene practices among pupils.

- **Drainage Enhancement at Tap Stands:** Ensure proper drainage systems (e.g., soak pits or channels) are finalized around the tap stands to prevent waterlogging and erosion, which could damage infrastructure and create sanitation hazards.

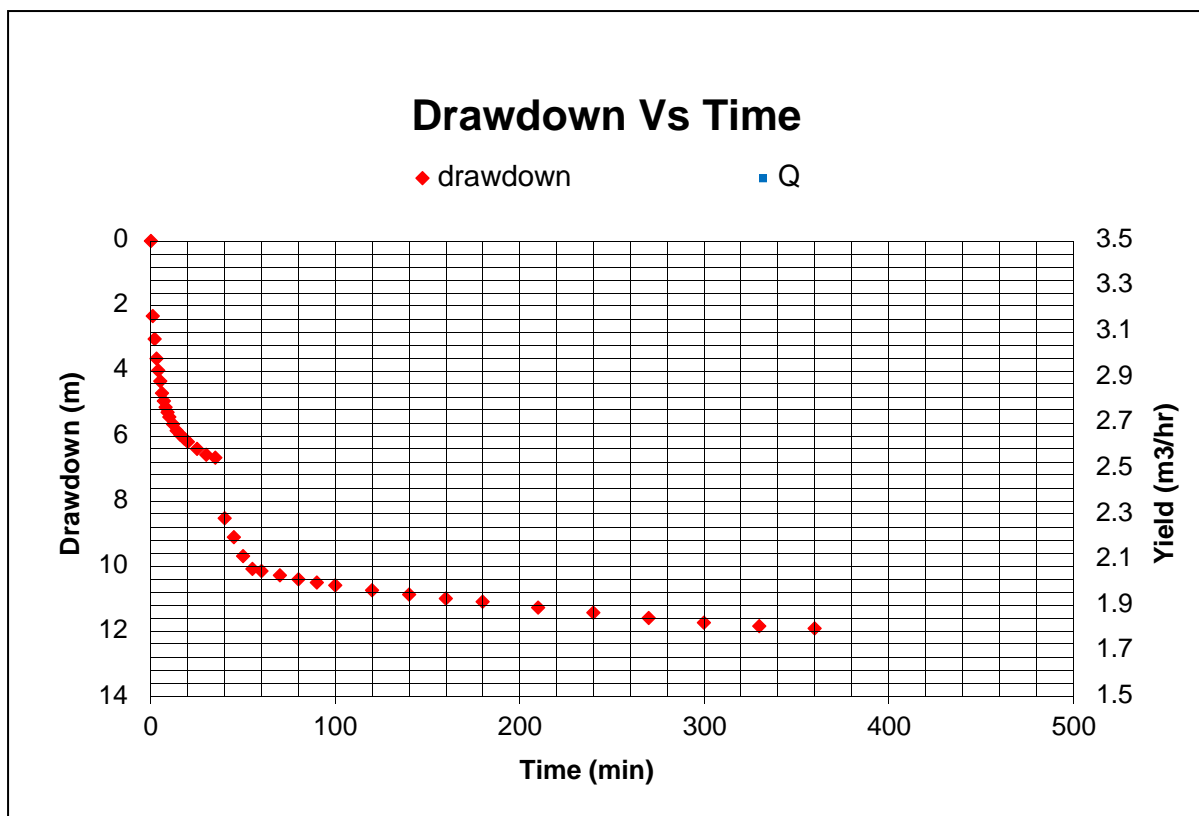
Annex 2: Test pumping results.

Time elapsed		Water level	Time to Fill	Yield	Remarks
min.	hour	mbgl	Seconds	m3/h	
0	0:00	6.28	25.00	2.45	Discharge starts off turbid
1	0:01	8.58	25.00	2.45	
2	0:02	9.29	25.00	2.45	
3	0:03	9.89	25.00	2.45	
4	0:04	10.25	25.00	2.45	
5	0:05	10.58	25.00	2.45	
6	0:06	10.95	25.00	2.45	
7	0:07	11.19	25.00	2.45	
8	0:08	11.38	25.00	2.45	
9	0:09	11.54	25.00	2.45	
10	0:10	11.68	25.00	2.45	Still turbid
12	0:12	11.90	25.00	2.45	
14	0:14	12.10	25.00	2.45	
16	0:16	12.23	25.00	2.45	
18	0:18	12.34	25.00	2.45	
20	0:20	12.44	25.00	2.45	
25	0:25	12.66	25.00	2.45	
30	0:30	12.84	25.00	2.45	
35	0:35	12.93	25.00	2.45	
40	0:40	14.79	19.00	3.22	
45	0:45	15.37	19.00	3.22	
50	0:50	15.95	19.00	3.22	
55	0:55	16.34	19.00	3.22	
60	1:00	16.41	19.00	3.22	
70	1:10	16.54	19.00	3.22	Discharge starts to clear
80	1:20	16.66	19.00	3.22	
90	1:30	16.76	19.00	3.22	
100	1:40	16.85	19.00	3.22	
120	2:00	17.00	19.00	3.22	
140	2:20	17.13	19.00	3.22	
160	2:40	17.25	19.00	3.22	Clear discharge

180	3:00	17.35	19.00	3.22	
210	3:30	17.53	19.00	3.22	
240	4:00	17.69	19.00	3.22	
270	4:30	17.85	19.00	3.22	
300	5:00	17.99	19.00	3.22	
330	5:30	18.10	19.00	3.22	
360	6:00	18.17	19.00	3.22	Pumping stopped for recovery
